Fatigue and Vibration Parameters Improvement of Steel DIN 41Cr4 by Ultrasonic Shock Peening Treatment

The effects of the ultrasonic peening treatment (UPT) on the rotating bending fatigue behavior and the behavior of the vibrations of alloy steel DIN 41Cr4 were studied. Hardness test, Tensile test, Constant amplitude fatigue tests, and the vibrations measurements have been carried out on the specimens. Also, the fracture surface was examined and analyzed by a Scanning Electron Microscope (SEM). The results of the investigations, e.g. stress to number of cycles to failure (S-N) curves, fatigue strength improvement factor was 7%. The decreasing percentage of maximum Fast Fourier Transform (FFT) acceleration of the ultrasonic peened condition compared to the untreated conditions was 45%.

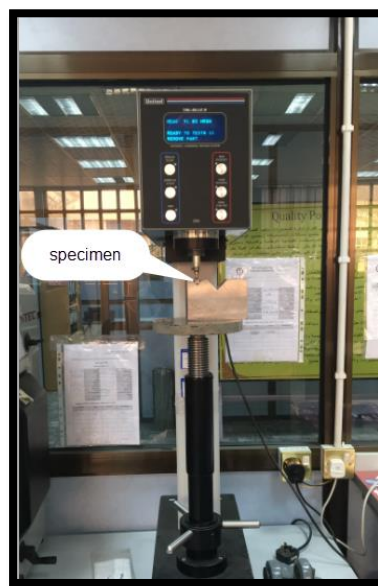
Figure (1): Rockwell hardness tester.

The Rockwell hardness test was performed at (the State Company for Inspection & Engineering Rehabilitation (S.I.E.R), laboratories and engineering test department, Ministry of Industry and Mineral, Baghdad, Iraq) according to ISO 6580. This test was performed by using TRUE-BLUE II hardness tester as shown in Fig. 1.

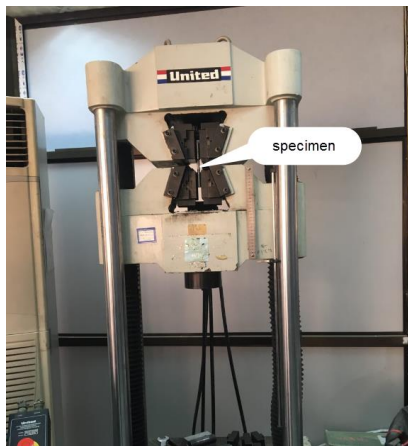
Figure (2): Tensile test machine UNITED.

Tensile test was performed by using tensile test machine type UNITED, as shown in Fig. 2, to obtain the mechanical properties like yield and ultimate strength, % elongation, and Young's modulus. The specimens were manufactured according to the American Society for Testing and Materials specifications ASTM (E8/E8M-011) as shown in Fig.3.

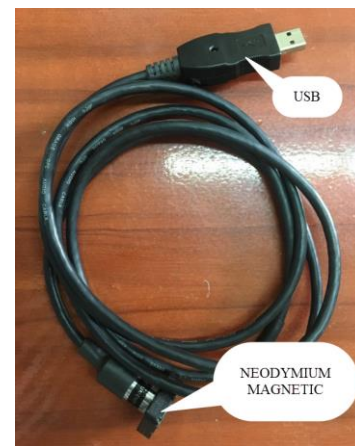
Figure (6): ERBESSD INSTRUMENTS accelerometer.

The accelerometer type (ERBESSD Instruments) one end is the Neodymium Magnetic base (connected with the structure to be measured) and the other end a USB outlet joined to a computer to analyze the output signal by EI-CLAC software program as explained in Fig. 6.

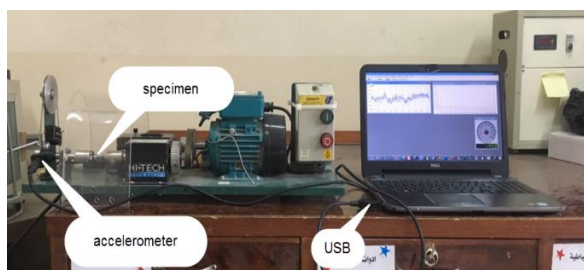
Figure (7): vibration measurement.

The behavior of maximum acceleration and the maximum FFT acceleration were examined of the fatigue specimen when it was tested on the fatigue test machine under the same condition that was used in the fatigue test by using the accelerometer. The aim of the test is to study the effect of the ultrasonic peening treatment on the maximum acceleration and the maximum FFT acceleration. Where the cable is put on the bearing of the shaft in the fatigue test machine as illustrated in Fig. 7.

The process of the vibration measurement was driven by the computer by using EI-CALC software program. EI-CLAC is an application of real-time vibration analysis with a complete range of spectral analysis tools and comprehensive graphical solutions. The spectral analysis tools in EI-CLAC based on the FFT algorithm. To be easy to measure the required frequencies and root mean square (RMS), the signal from its time-domain description transforming to the frequency-domain description.

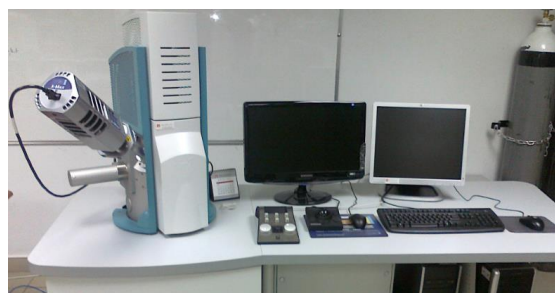
Figure (10): Scanning Electron Device (SEM).

The broken samples after the fatigue test were examined at (Production and Metallurgical Engineering Department, University of Technology, Baghdad, Iraq) by using scanning electron microscope TESCAN, VEGA 3 LMU with OXFORD EDX detector (INCA XMAW20) device as shown in Fig. 10 to determine the beginning of the crack and its propagation, size, form, and microstructure.
